Manhole Inspection Summary

Manhole # S23GG1030MH

Location Address: **1323 WELDON AVE**

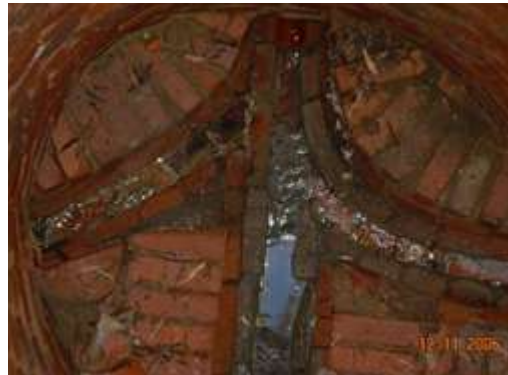
Top View

Bench ☒ Exists Material: **Brick** ☐ Parged ☒ **Debris** (not Condition related)

Condition: ☐ Sound ☐ Cracked ☐ Root Intrusion ☒ **Deteriorated** ☐ Leaks ☐ Debris

Bench deterioration and debris.

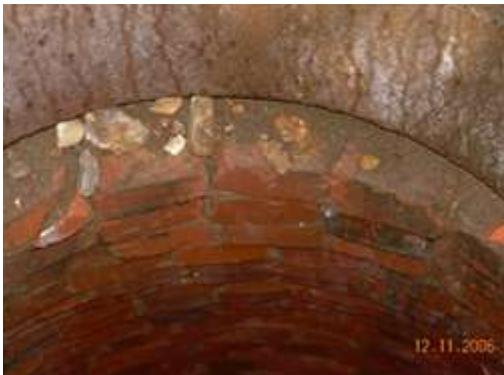
Defect

Frame Offset: **2** (in.) Condition: ☒ Sound ☐ Cracked ☐ Leaks

Condition: ☐ Sound ☐ Cracked ☐ Root Intrusion ☐ Loose Brick ☒ **Deteriorated**

Infiltration: ☐ None ☒ **Joint** ☐ Cracks ☒ **Mortar** ☐ Roots ☐ Wall

Frame offset. Adjustment deterioration and infiltration.

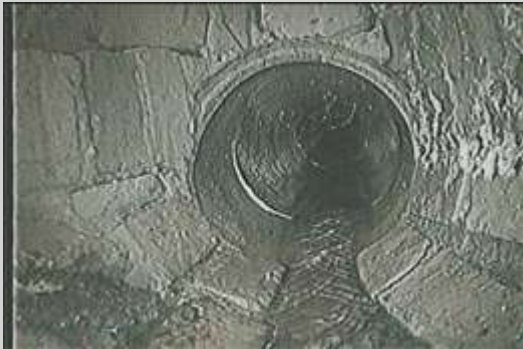
8 in. Circular Gravity Sewer Pipe Out @ 12 O'Clock

Infiltration: **None** Pipe Seal Cond: **Cracked**

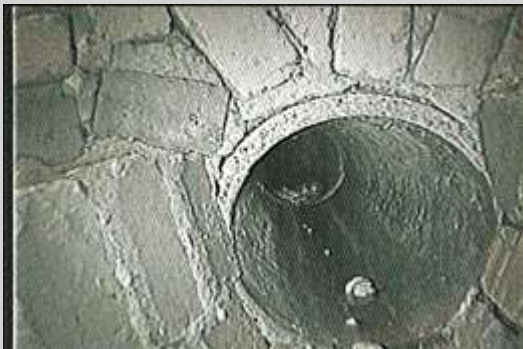
8 in. Circular Gravity Sewer Pipe In @ 3 O'Clock

Infiltration: **Evidence** Pipe Seal Cond: **Cracked**

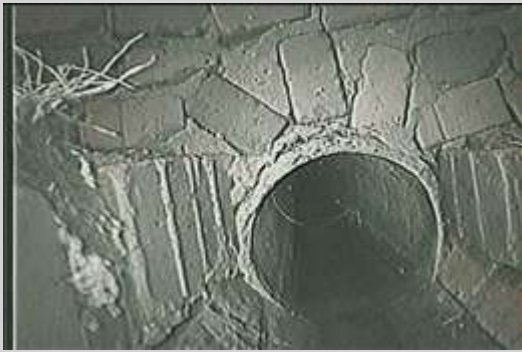
Pipe In @ 6 O'Clock

Condition: ☐ Sound ☐ Cracked ☐ Root Intrusion ☐ Loose Brick ☒ **Deteriorated**

Infiltration: ☐ None ☐ Joint ☐ Cracks ☒ **Mortar** ☐ Roots ☐ Wall

Condition: ☐ Sound ☐ Cracked ☐ Root Intrusion ☒ **Deteriorated** ☐ Leaks ☐ Debris

Barrel deterioration and infiltration. Channel deterioration.

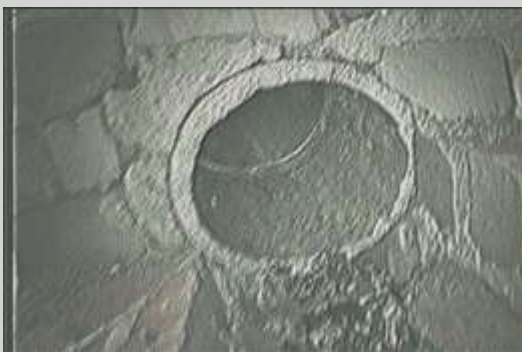
Pipe In @ 9 O'Clock

Deposits: ☐ None ☐ Mud ☐ Sludge ☒ **Debris** ☐ Grease

Silt Depth: **0** (in.) Deposits Extent: **Light**

Infiltration: **Evidence** Pipe Seal Cond: **Unknown**
